# Warship on a collision course

A US Navy investigation report sheds light on the final moments leading to the fatal collision between the USS John S. McCain and tanker Alnic MC on Aug 21, resulting in the deaths of 10 US sailors.

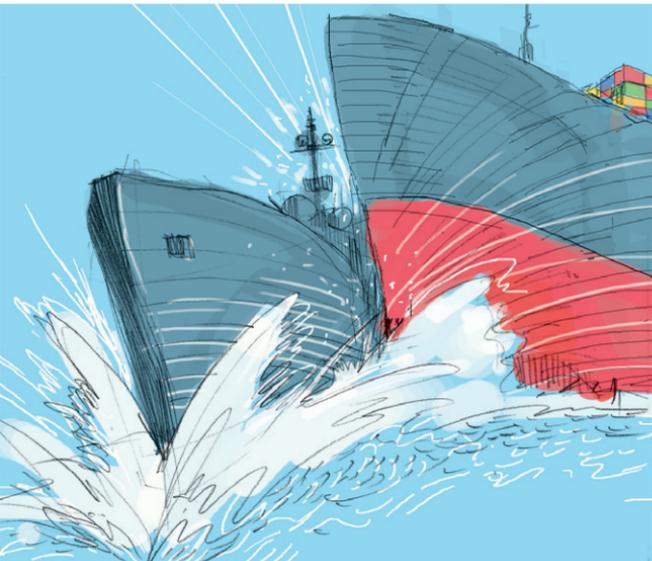
### Confusion and loss of control

**At 5.19am** The commanding officer (CO) of the USS John S. McCain notices the helmsman, whose duty is to steer the ship, having difficulty keeping course and speed. The CO then divides the duties. He assigns one sailor to steer and another to control the throttle. This leads to some confusion when steering control is inadvertently transferred to the sailor in charge of the ship's speed. The combination of wrong moves that affected the rudder and the two propeller shafts causes the USS John S. McCain to be steered towards the left, in the direction of three ships, including the Alnic MC.

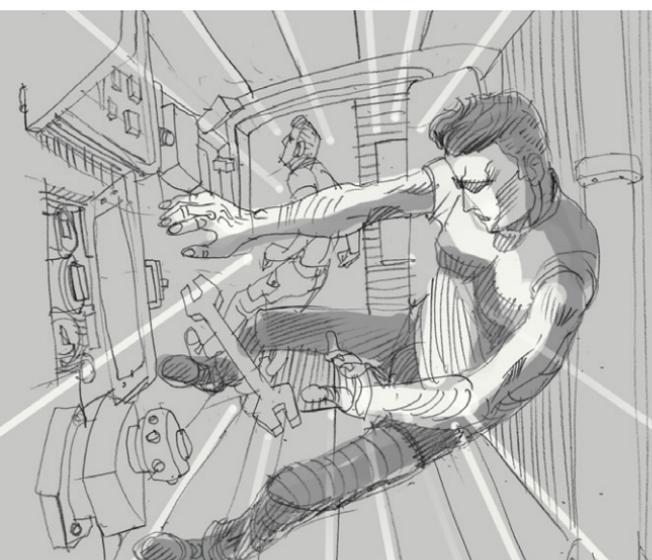
### Collision course

**At 5.20am** USS John S. McCain enters the busy Traffic Separation Scheme in the Singapore Strait. Roughly three minutes from the time a loss of steering is reported, the warship regains steering control. However, steering and speed corrections are made too late. Just before 5.24am, the USS John S. McCain crosses in front of Alnic MC's bow and collides with the tanker.

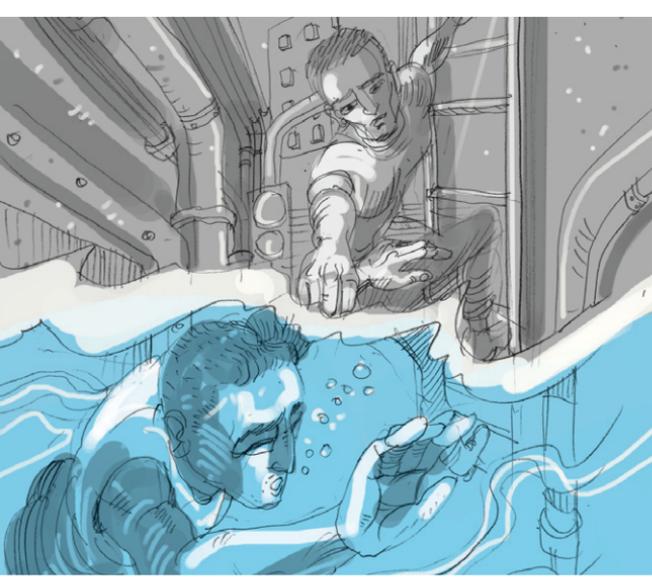
### Impact

**Just before 5.24am** The collision between Alnic MC's bulbous bow and the USS John S. McCain leaves a hole roughly 8.5m in diameter on the left, near the rear of the warship. Crew compartments, known as Berthings 3 and 5, are struck. The impact is felt throughout the warship and some sailors are thrown off their feet. A few thought the ship had run aground, while others feared an explosion or an attack.

### Escape and rescue

**About 5.26am** An alarm is sounded to begin damage control efforts. There is flooding, internal fuel leaks and loss of ventilation as well as internal communications. One of the sailors in Berthing 5, with injuries to his back and legs, scrambles up a ladder to flee the compartment which is being flooded by seawater and fuel. A rescue attempt to enter the compartment fails after a sailor is forced back up the ladder by the pressure of escaping air and rising water. Just as he leaves, the rescuer sees another sailor swimming towards the exit and yanks him out of the water. Ten other sailors in Berthing 5 do not make it out.
